Metropolitan Sewer District of Greater Cincinnati

**Enabled Impact Program:
Interim Summary Report – November 2013**

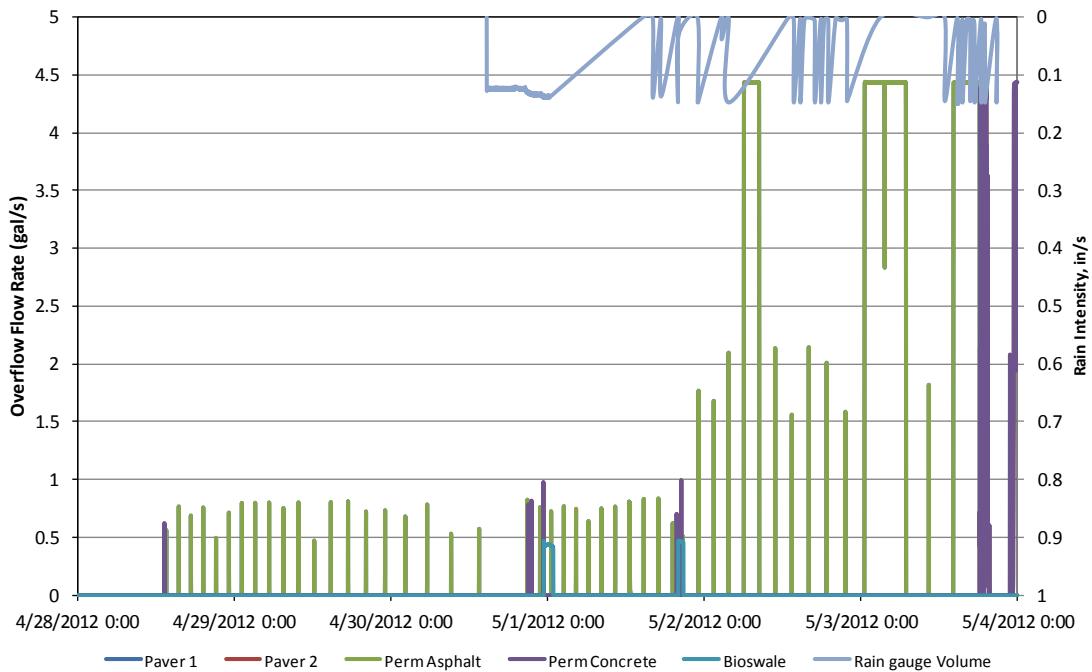
Figure 4: Paver response for example storm event.

The flow rate time series of Paver 1 and Permeable Asphalt demonstrate nearly identical responses to each other (making it difficult to see both colors on the graph), as do Paver 2 and Permeable Concrete. Both the Paver 3 and Concrete flow rate time series were missing data during this storm event. The Bioswale triggered an overflow only twice.

While the analysis of the pavement data for individual rain events and overall patterns observed over the course of a year provides useful information, it does not represent a complete picture of the performance of these systems. GLC team must pair what the data is revealing with what is observed on the surface during rain events. Unfortunately up to now the team has not had a consistent way to make surface observations given the unpredictable and sometimes inconvenient timing of rain events. Until the team has improved monitoring infrastructure to capture these missing data points, the team takes advantage of rain events to observe the systems in action. For example, Pervious Asphalt seems to absorb the most rain given that there is less water overflowing from the system. However, during recent observations in heavy rain events, a large portion of the surface area is generating sheet flow, causing water to pool at the down slope end of the pavement and drip into the manhole lid. Part of our upcoming work is to better understand why Pervious Asphalt's data appears as it does given what we have observed during rain events.

Concrete is another surface whose data needs illumination: it is not appearing in the data as producing the highest overflow volume of the pavements even though it is the only impervious surface in the study. We have started to make observations during rain events to determine if any rain is moving from the concrete surface onto other pavements. During at least three rains in the summer of 2013, rain was observed sheet flowing from the surface of Concrete onto Paver 1. This would affect the data in two ways: Concrete

Paver 3 has presented itself as an outlier in many ways. It is the one pavement that has a different shape and grading than the other five. It is located under trees that shed a large amount of fine organic matter. It seems to be plumbed in such a way that water from another part of the site is leaking into its catch basin in a way that has not responded to attempts at modification. For these reasons, it appears to be behaving quite differently than the other pavers, and is being removed from the flow analysis study.

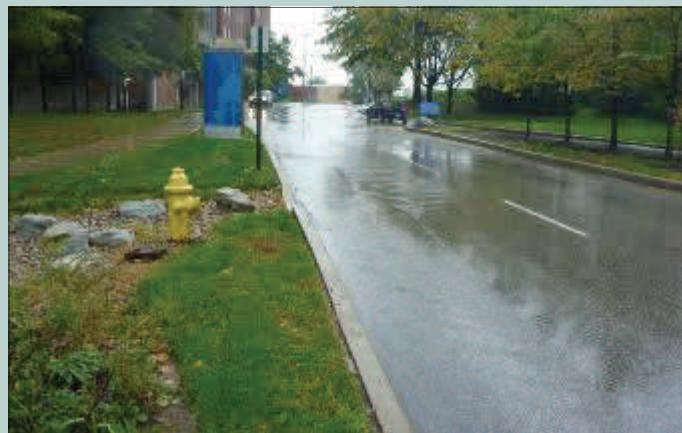
A significant amount of the stormwater runoff from the adjacent roadway bypasses both bioinfiltration basins at Christ Hospital, drains to a downstream inlet, and enters the combined sewer system. Designs should optimize stormwater runoff directed into the facility. Potential solutions include installing curb and gutter with a depression in the pavement to direct stormwater into the facility; placing the bioinfiltration basins further downstream adjacent to the existing inlet into the combined sewer system; or potentially installing a small “bump out” to help direct stormwater into the facility.

Stormwater runoff bypasses the curb cut to the rain garden.

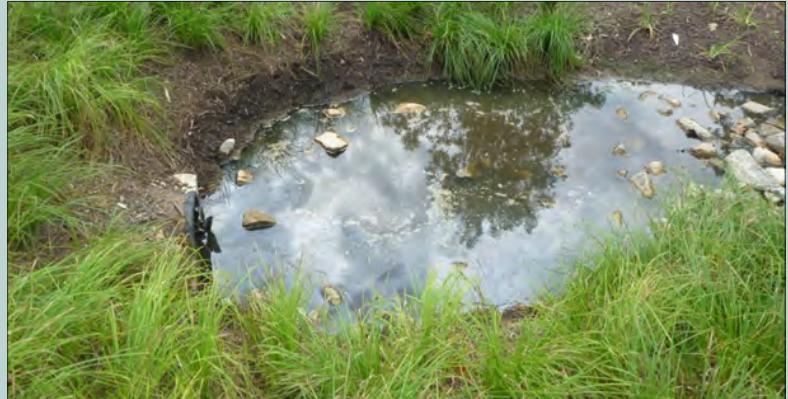
The inlets into the bioinfiltration basins were designed with low entry elevations and a clay berm surrounding the inlet to the basin to create a sediment forebay. This design did not allow stormwater to drain out of the forebay section, and the ponding has caused stagnation and mosquito breeding in this area. Bioinfiltration basins, including forebay features, should be designed to fully drain within 48 hours of the rain event.

Water ponded in this forebay caused stagnation and conditions amenable for mosquito breeding.

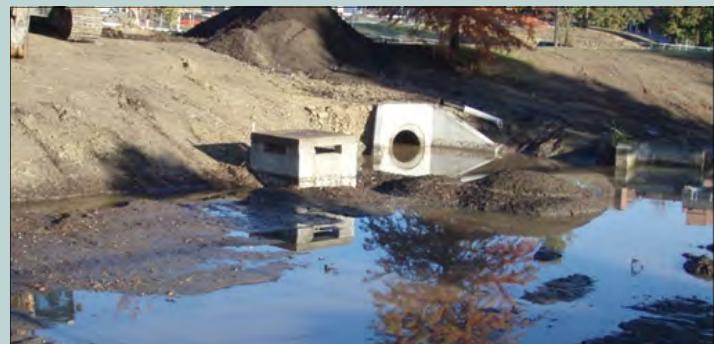
If a rain event occurs while the amended soil or gravel is being placed in a green feature and a silt fence has not been installed around the green feature, native and exposed materials on the construction site will wash into the open green feature clogging the amended soil or gravel with silt and sediment. Installing and maintaining a silt fence around the green feature before material is placed is recommended. This is critical to the performance of the green feature. Ultimately, the top eight to ten inches of accumulated sediment was removed prior to completing the installation.

After a rain event, stormwater ponded and sediment built up on top of the bioinfiltration basin's amended soil.

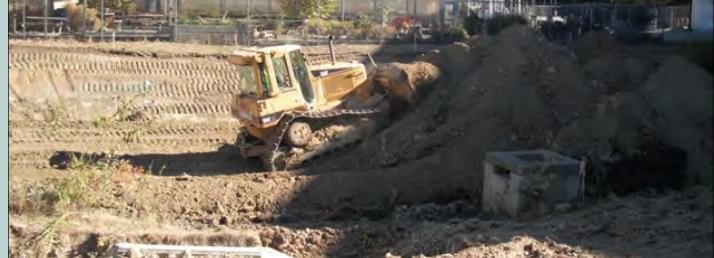
Maximizing infiltration rates of the native soil is crucial to the success of installed green features. When heavy equipment is driven over the surface, the underlying soil is compacted and infiltration capabilities can be significantly reduced. Soil here was scarified prior to installation of the remaining components of the green feature.

Heavy construction equipment compacts the native soil

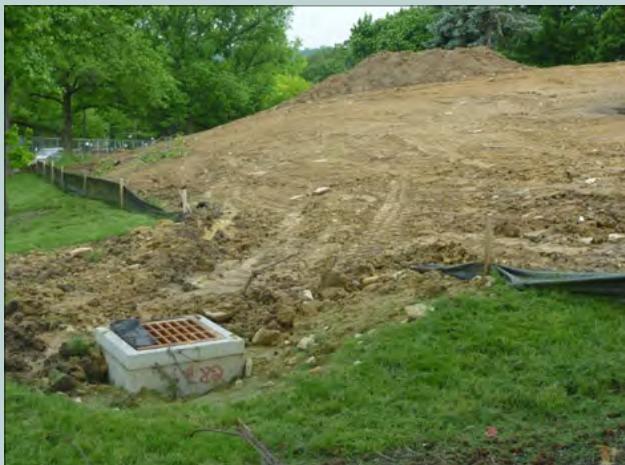
Exposed soil is more susceptible to erosion; and therefore, when vegetation is removed during construction, proper measures for erosion protection and sediment control should be taken. This is particularly important during construction of green features which can be easily clogged if silt and sediment wash into the proposed system.

Broken silt fence promotes erosion and sediment build up in the proposed green feature.

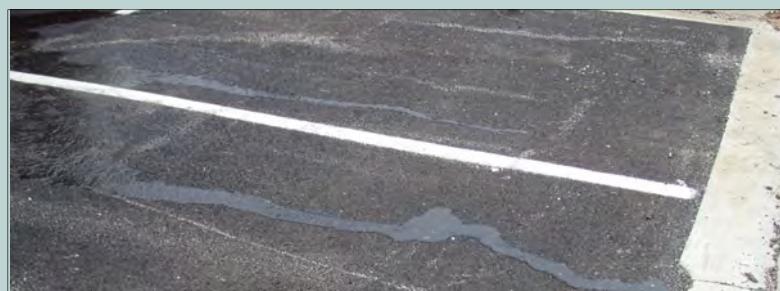
At Cincinnati State, a test was performed by pouring water directly onto dry, porous asphalt pavement and some of the water appeared to runoff across the surface. Porous asphalt must be wetted before water will readily infiltrate into the pavement because the surface tension of dry, porous asphalt does not allow the water to infiltrate until it has been fully wetted.

Water does not infiltrate as readily on dry, porous asphalt.

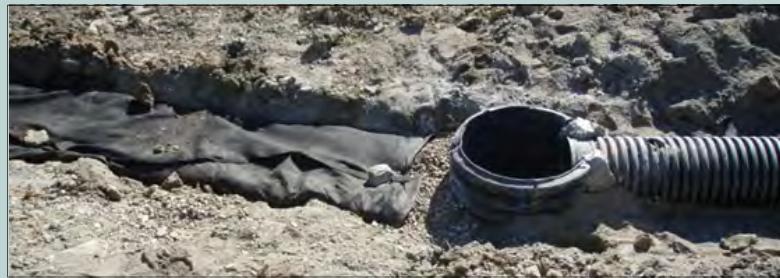
Studies have shown that even a small amount of silt can cause filter fabric around an underdrain to clog. Underdrains should be designed to minimize the probability of clogging. The contractor must take extra precautions to prevent clogging prior to and during installation.

Filter fabric and an underdrain being installed.

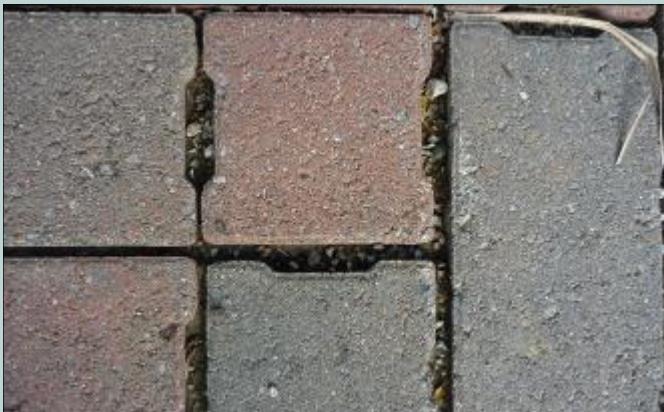
When sloped, mulched planting beds are adjacent to porous pavers, a barrier should be installed on the edge of the mulched planting bed to help prevent the mulch and soil from running off and spreading over the porous pavers. This sediment builds up in the porous paver system and prevents infiltration. The Zoo vacuumed the affected areas to remove accumulated materials. A concrete curb keeps mulch in place in planted area at right.

Sediment built up in the porous paver system.

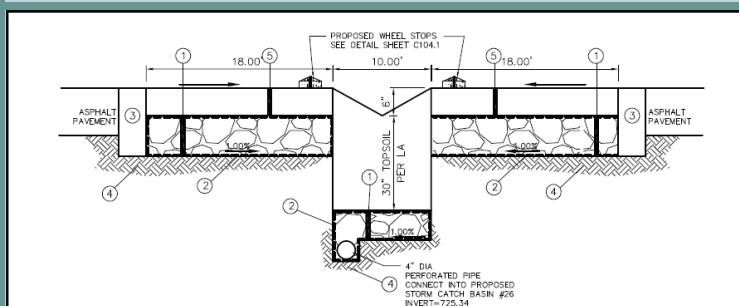
Cross Section of Porous Concrete and Bioswale

The porous concrete was poured without a permanent curb between the concrete and the bioswale. This was done to allow runoff to flow directly into the sub-surface of the bioswale after infiltrating through the porous concrete parking stalls. Wheel stops are used in place of a curb to stop cars from driving into the bioswale and compacting the soil. During construction, the perforated pipe was installed, but not connected to the downstream catch basin, as the soils were sandy enough for full infiltration of the runoff.

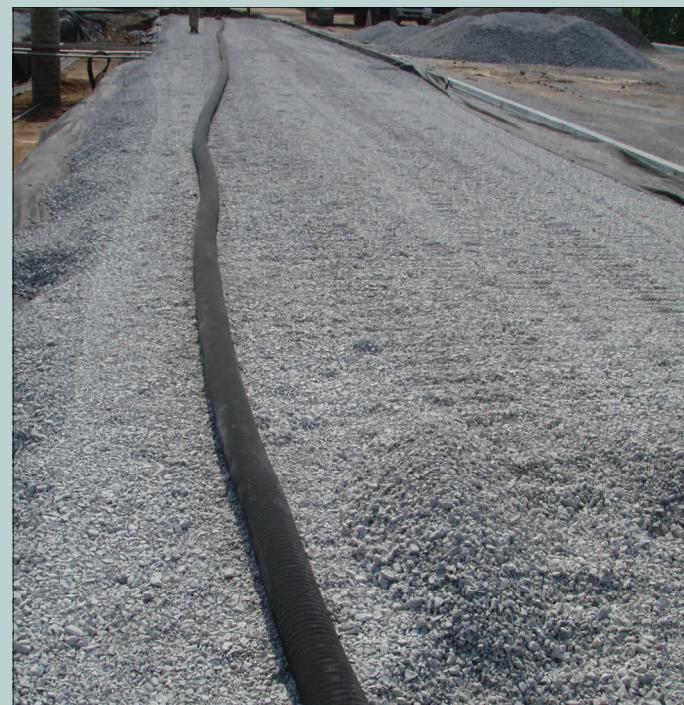
Soil testing was completed on site, but not in the exact location of the proposed green feature locations. During construction, sand seams were found on site, which indicated that infiltration rates may be high, and therefore, underdrains may not be necessary. This finding was not brought to the attention of the design engineer or landscape architect on the project until much of the construction had occurred. At that point, one underdrain had already been installed, and all the underdrains for the site had been ordered. Although no additional soil testing was completed, the decision was made to plug the underdrain that was already installed and to install all other green features on site without underdrains. In some cases the engineered soil had also been placed. The soil contained sand, as per the design. The sand would make the feature drain too rapidly—so the engineered soil was removed and replaced with a non-sand soil mixture. This additional effort and cost may not have been necessary.

Underdrain to be installed in the bioswale.

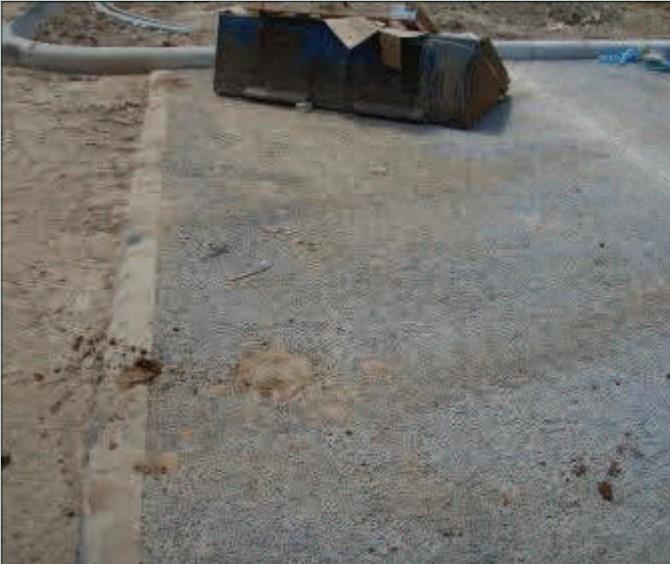
Sediment build up from mud on construction equipment was tracked over the gravel base of a pervious paver parking lot. Once the pavers were installed, this machinery continued to travel across the pavers with mud on the tires, causing the system to clog prematurely. In addition, the plastic was removed from the pervious concrete before finishing construction in the surrounding area, allowing excess silt and sediment to accumulate in the voids. The property owner will need to have the pavement area vacuumed to remove these materials.

Exposed dirt adjacent to the newly installed porous concrete can cause sediment build up and clog the system.

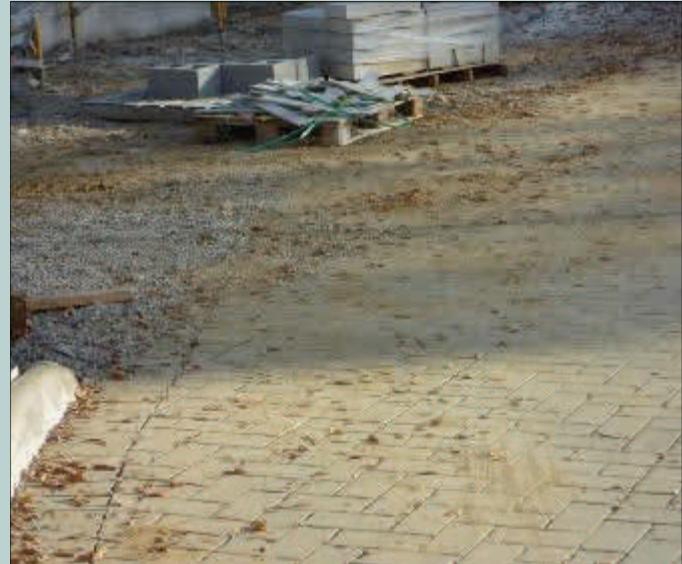
Exposed dirt adjacent to the newly installed porous paver system can cause sediment build up and clog the system.

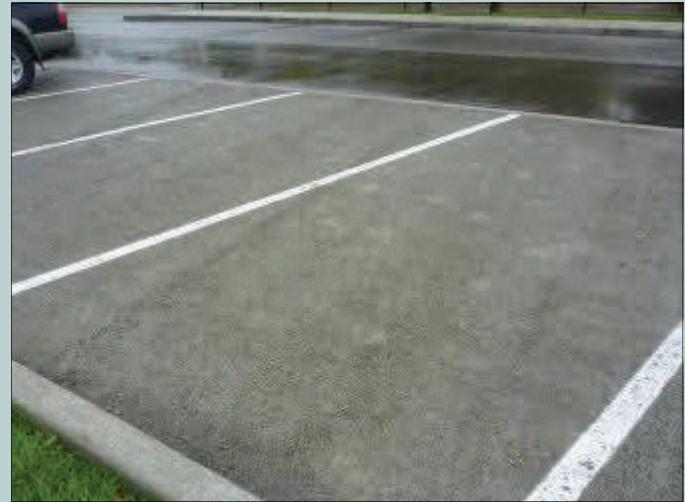
Despite geotechnical test results indicating the presence of sandy soils with high infiltration rates (greater than 6 inches per hour), only a small portion of the project site was designed to drain toward a green feature, pervious concrete parking stalls. In cases with soils favorable for stormwater infiltration, additional green infrastructure features should be encouraged to maximize the stormwater volume reduction benefit in these locations.

Porous concrete at Hartwell Elementary.

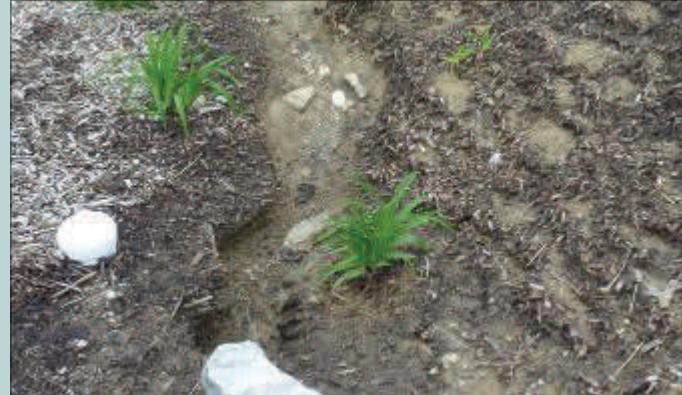
Concentrated flow paths can cause erosive flows and problems with erosion within bioinfiltration green features. Design considerations, such as energy dissipation at the outlet into the feature or minor tweaks to the grading, should have been included in the detailed design of the feature. As this was an early project in the program, energy dissipation was introduced into the design of remaining projects.

Erosion in the bioinfiltration basin.

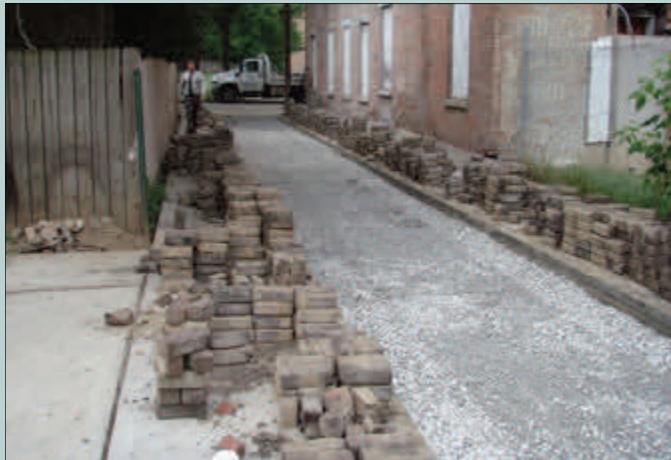
Existing pavers prepared to be reused as a porous pavement system.

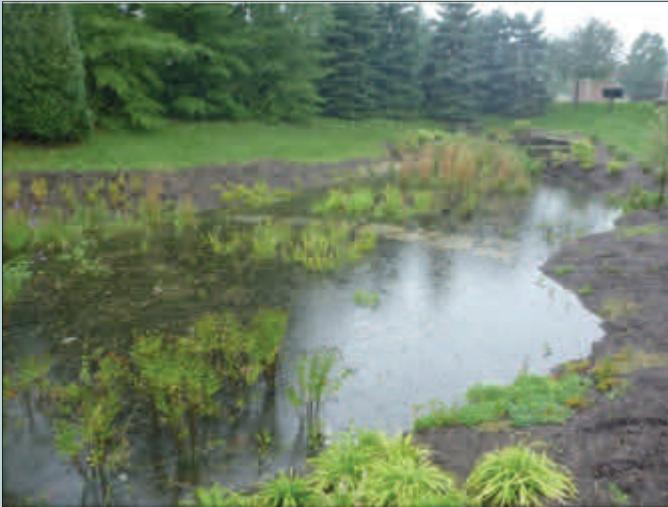
Stormwater ponded in the bioinfiltration basin during a rain event.

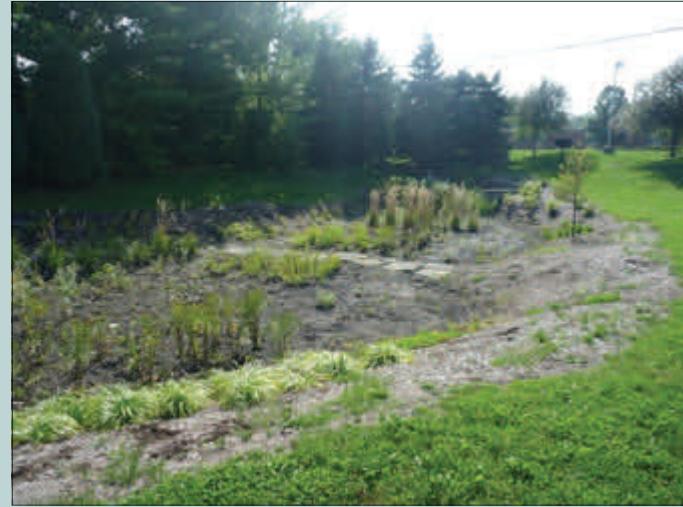
The stormwater has infiltrated through the system 24 hours after the rain event.
